# SPECIALIZED EQUIPMENT FOR FLANGE MILLING

Foundation Ex 2022 – CNC Onsite A/S

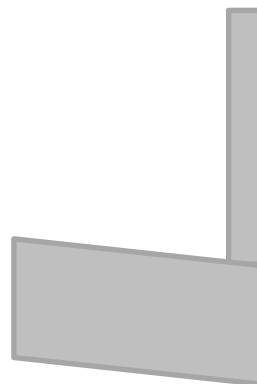
Tilted

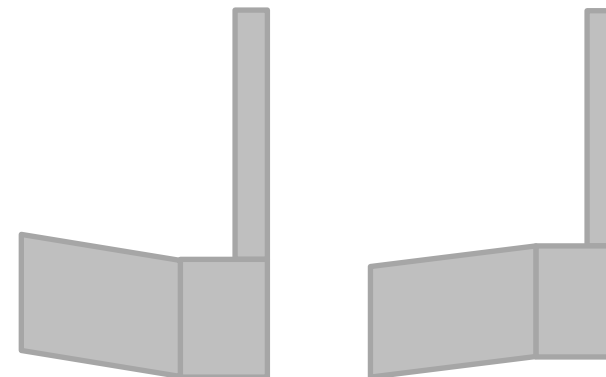
Double Tilted

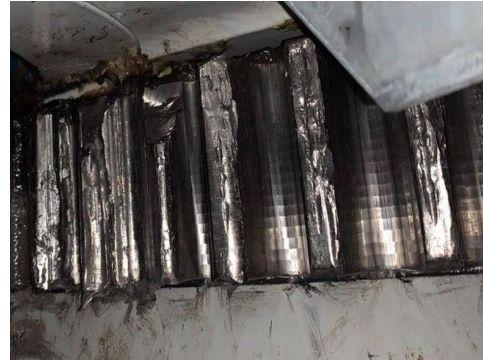
Damaged area

- Teeth get worn or brake
- Yaw ring exchange is expensive and time consuming

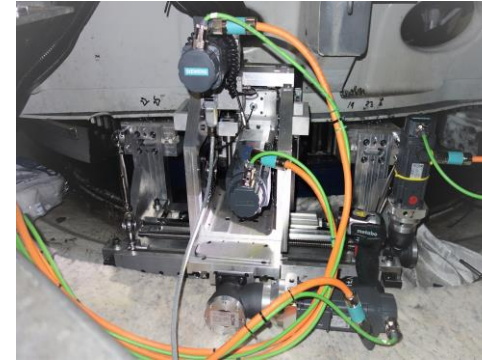
Machine mounted

Full CNC controlled machine. Can remove worn/damaged sections and a new segment can be bolted in place

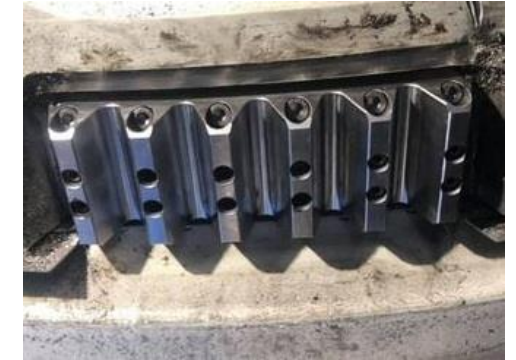
New segments

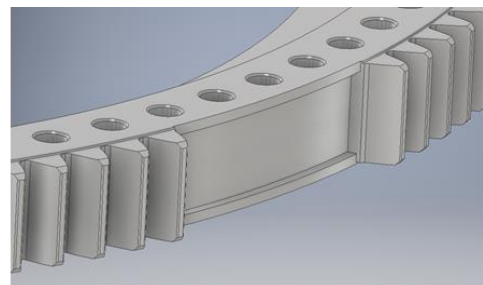
Step 1  
Milling the damaged area

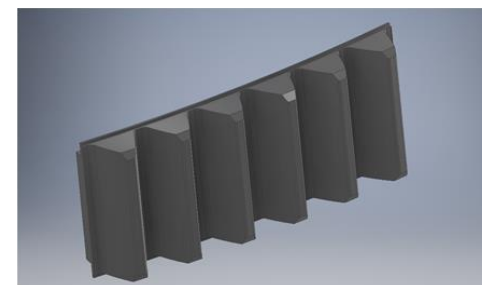
Step 2  
Freeze the segment and  
mount it with special tool

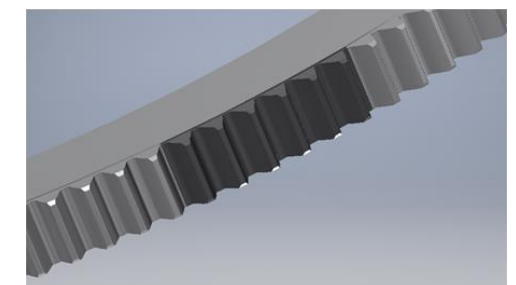
Step 3  
Fix the segment with bolts

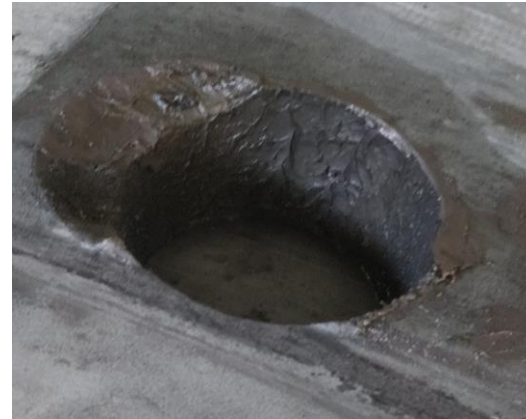
Damaged area

Rotor lock hole can get worn or damaged.

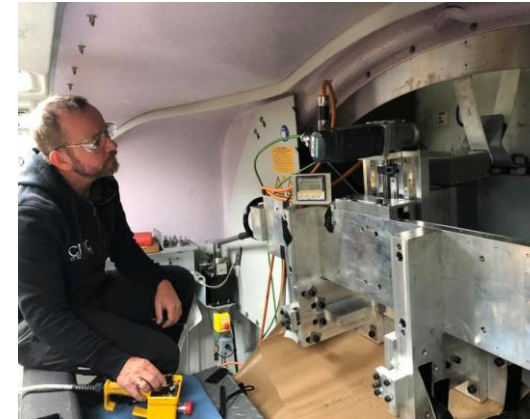
Machine mounted

Mobile machine for up-tower repair.

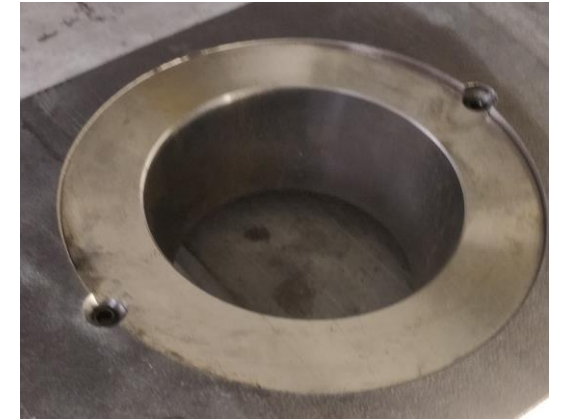
Repaired rotor lock
